NRL-MR-4845

4. TITLE (and Subtitle) MERCURY CONTAMINATION OF A COMMUNITY WATER SUPPLY - DIAGNOSIS AND RESTORATION		5. TYPE OF REPORT & PERIOD COVERED Final report.

MERCURY CONTAMINATION OF A COMMUNITY WATER SUPPLY DIAGNOSIS AND RESTORATION

John C. Cooper, Claudia J. Hackbarth, Christine M. Hellwig,
Rm. Panayappan and David L. Venezky
Inorganic and Electrochemistry Branch
Chemistry Division

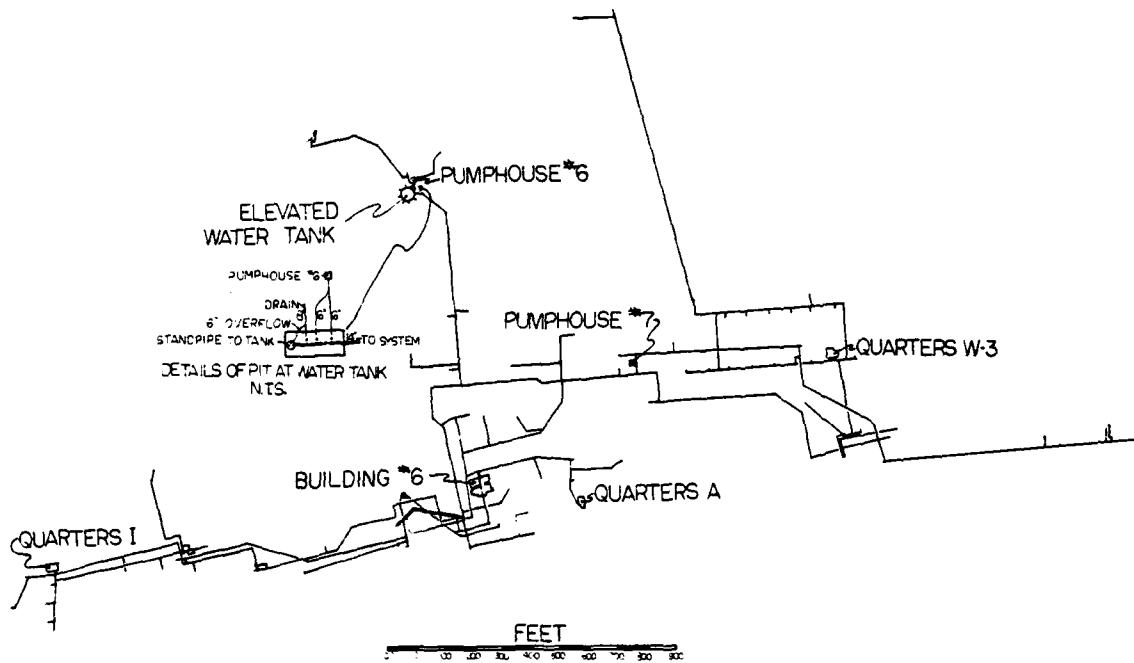
Fig. 1 - Drinking water distribution system major features, CBD/NRL.
 Routine sampling locations indicated.

tions. Three residences were chosen so as to allow sampling of three main portions of the distribution system (Fig. 1). In addition, regular sampling was done at Building 6 (a location used for some specific tests of sampling methods), pump house 6 (the contaminated well), and pump house 7 (to insure the integrity of the water supply in use and to check for possible geological migration from well no. 6). Sampling at these locations was done on a weekly schedule with additional sampling during periods of system perturbation.

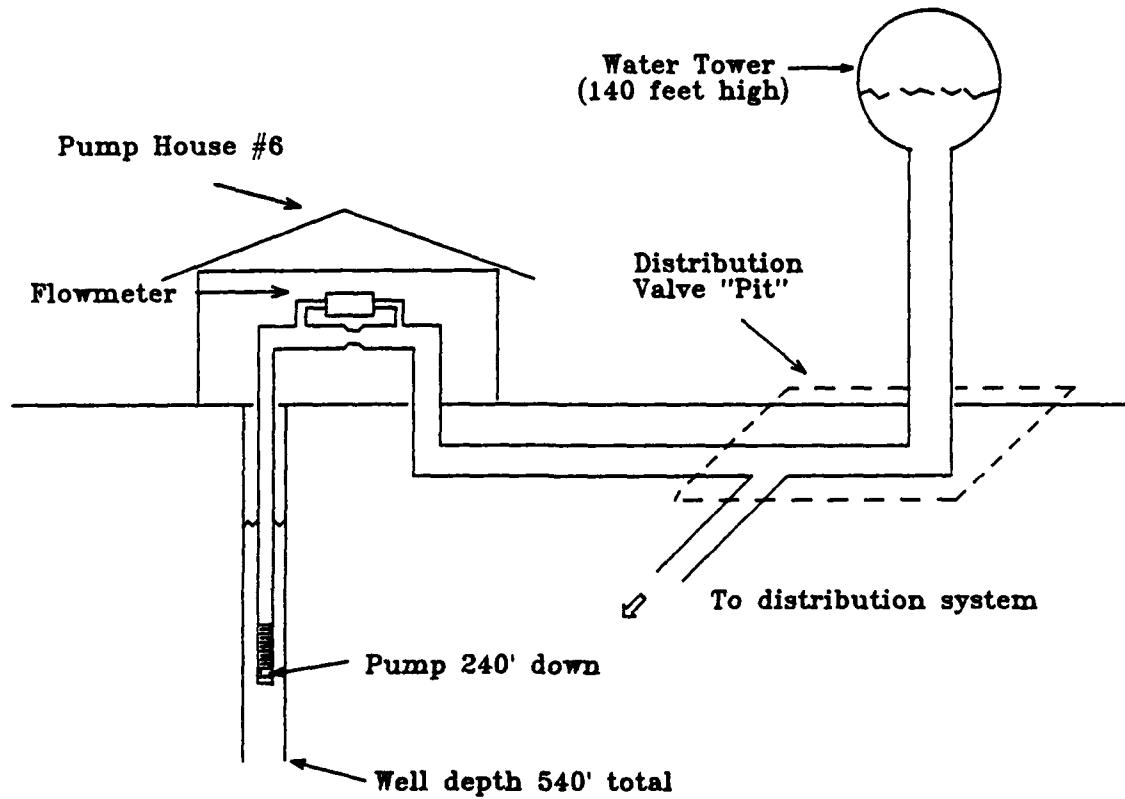
Fig. 2 - Schematic of well system. (not to scale).

Figure 2 shows the relationship of the well pumphouse where the mercury entered the system to the water tower and distribution valve area. The 8-inch well is a total of 540 feet deep through alternating shale and sandy loam aquifers. A submersible pump and a check valve are located at the bottom of a 240 foot inner sleeve of 4-inch black iron. The actual water level is approximately 100 feet above the pump under normal conditions. A mercury flow meter of a Ledoux Bell design (Figure 3) measures water flow by calculation of the pressure differential on either side of a standard orifice. The combined effect of a faulty check valve above the pump, the location of the

mercury flow meter with respect to a second functional check valve and the limited tolerable pressure differential of the flow meter was to siphon mercury from the flow meter into the line leading from the well. Immediate action was taken to prevent further contamination, diagnose the problem, and restore the system to safe concentrations of mercury. The sequence of events to accomplish these goals are reported here, and the appendix tabulates, chronologically, mean values of analyses performed through October, 1978.

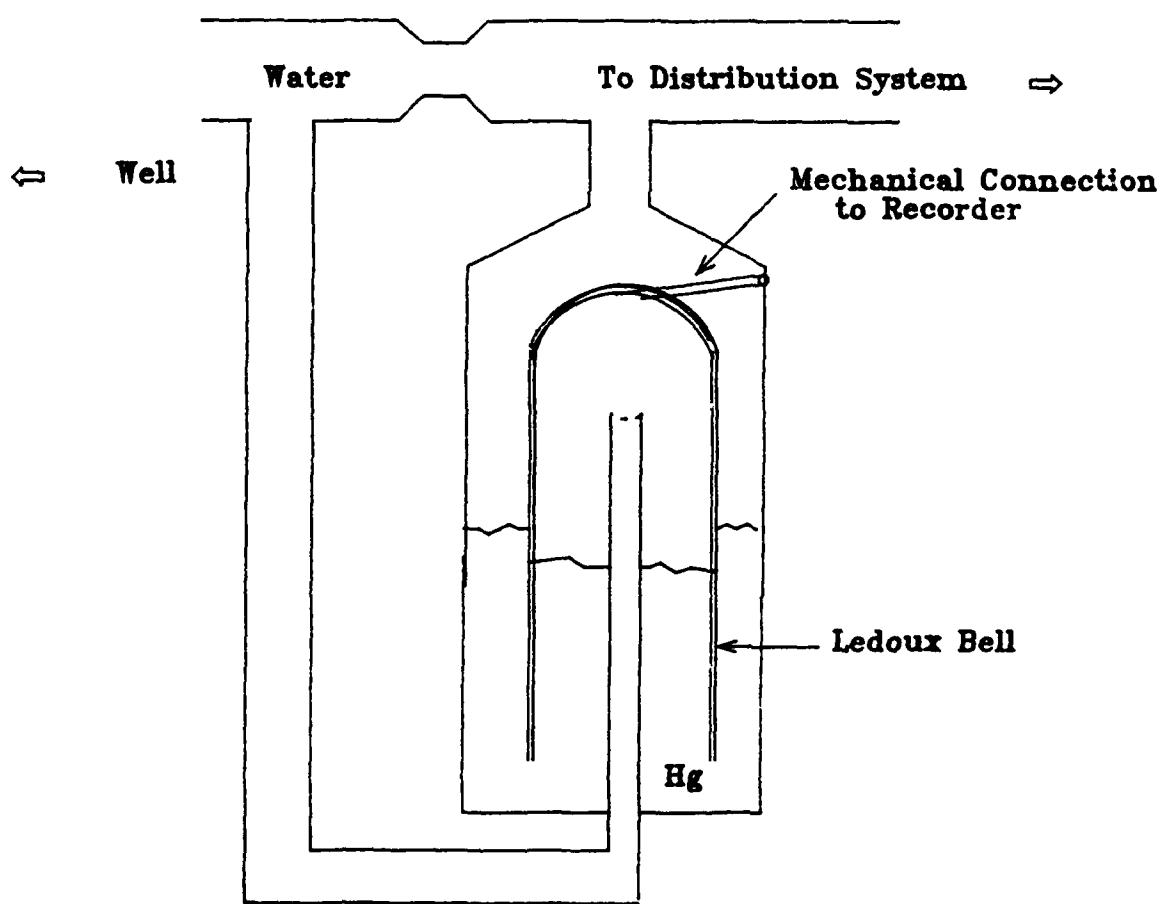
Fig. 3 - Approximate design of mercury flow-meter which delivereded mercury into water system.

The first evidence that a problem existed was the indication from flow meter service personnel that several pounds (between 7 and 14.5 lbs) of mercury had been replaced. Subsequent analysis of a single sample from a residential location (Quarters A in Fig. 1) showed a total mercury concentration of 97 $\mu\text{g}/\text{l}$, a level some fifty-fold higher than the established maximum permissible level for public drinking water supplies of 2 $\mu\text{g}/\text{l}$ ⁶ and some 2000 to 5000 times the likely background levels.^{7,8}

It is clear that malfunctioning or incorrectly installed mercury-containing water flow meters in use in public drinking water systems pose a significant threat to health. It is also clear that the time and expense involved in correcting a mercury spill of this sort is significant. It is recommended that water supplies using mercury flow meters of this sort insure that they are correctly installed, that regular mercury analyses be performed, and that no mercury be added to such meters without suspecting loss into the system and determining its destination.

A simpler solution is to remove these meters altogether. It is likely that sufficiently accurate flow measurements can be obtained with other devices or by monitoring the time that pumps are running.

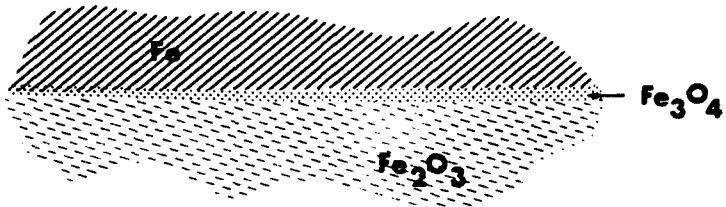
Fig. 5 - Model of iron oxide scale formed on surface of iron plumbing.

A chemical cleaning method was devised for the distribution valve area, based in part on generally used procedures for hot-water boiler cleaning and cleaning of metal surfaces in ship bilge areas. In order to evaluate the quantity of chemicals required and the need for removing scale, an Auger analysis was made of both sides of a carefully removed piece of scale. The iron oxide scale was typical, consisting of a magnetite layer (Fe_3O_4) separating the iron pipe from a porous surface coating of Fe_2O_3 (see Figure 5). The Auger

results and mercury analyses of a small section of the scale sample indicated that all mercury was contained in the outermost portion of the magnetite layer and the Fe_2O_3 layer. Cleaning would therefore require little disruption of the protective inner magnetite coating. This result was confirmed by carefully separating portions of scale from both sides of a scale sample - only the exposed Fe_2O_3 surface contained appreciable amounts of mercury. A multi-step process was developed, beginning with acid-catalyzed chelation to remove the bulk of the mercury. The formulation chosen was a mixture of ethylene-diaminetetraacetic acid (EDTA) and citric acid (H-Cit). Laboratory experiments using the removed section of 14-inch cast iron pipe allowed optimization of pH and concentrations. Citric acid and EDTA were chosen for two reasons. First, citric acid, acting as a general acid, can catalyze dissolution and complexation of hydrous iron oxides, thus increasing the rate at which mercury is liberated from the scale and available for complexing. Secondly, both citrate and EDTA have favorable formation constants for mercury(II) complexes compared to iron(II). The first formation constants are summarized in Table 1.

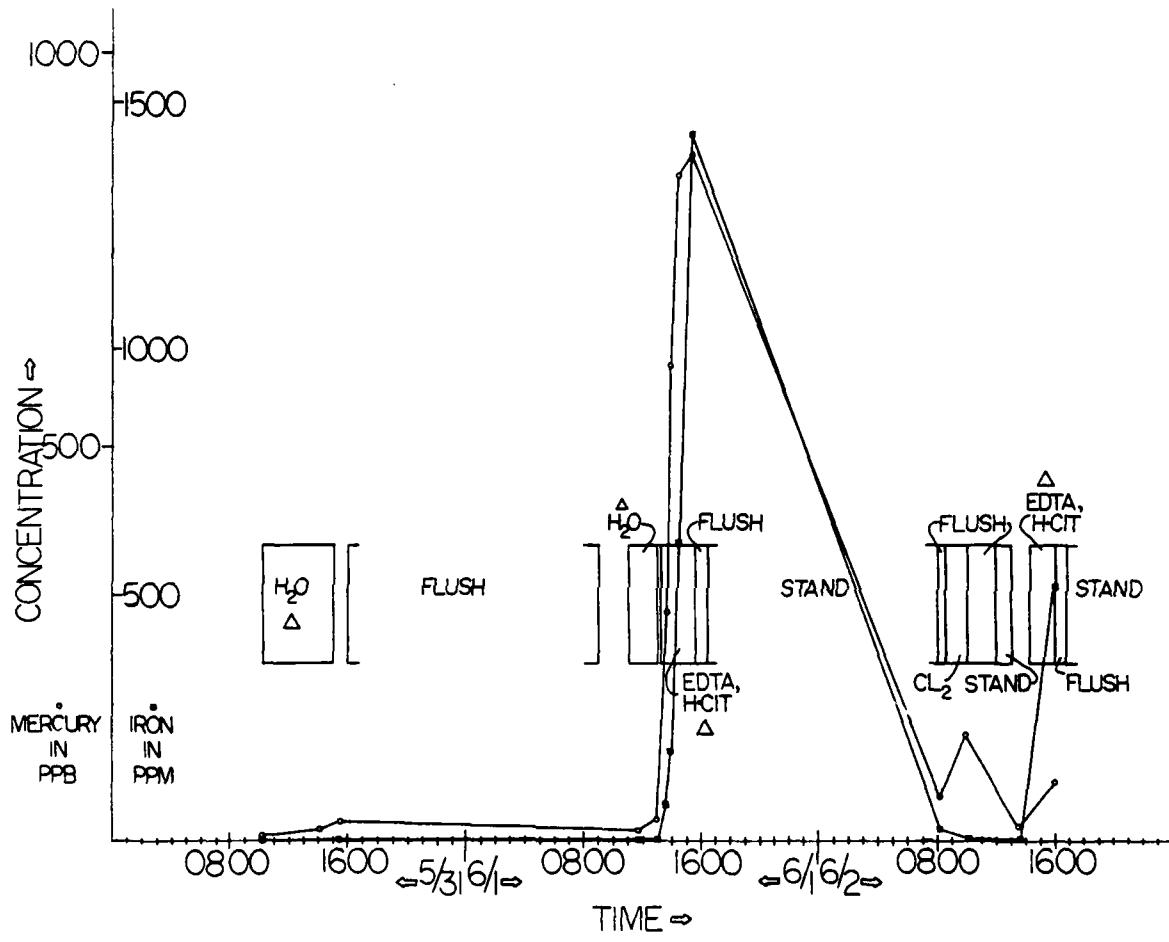
Fig. 6 - Iron and mercury analyses during clean-up of distribution value area.

The EDTA/citric acid formulation devised was 125 lbs. Hampene NA3T (Na_3HEDTA) and 100 lbs of citric acid in about 400 gallons of water heated to about 60°C while circulating through the system. This mixture gave the optimum final pH of 3.5 and still allowed fairly high concentrations of the EDTA. After cleaning with citric acid/EDTA, the system was flushed with water and treated with super-chlorinated water (1 lb. $\text{Ca}(\text{OCl})_2$ in 400 gal) to oxidize any mercury(0) or mercury(I) to soluble mercury(II), and finally by another EDTA-citric acid treatment. The cleaning was monitored by mercury and iron analyses. The results are shown in Figure 6. Several important points are evident in these results: (1) The second EDTA-citrate treatment removed a proportionately much smaller amount of mercury, indicating that only a small portion was present as elemental mercury or mercury(I) and that the initial cleaning was very successful. (2) The chlorination did not remove iron (magnetite). (3) The total amount of mercury removed agreed fairly well with estimates based on mercury concentration in the scale samples.

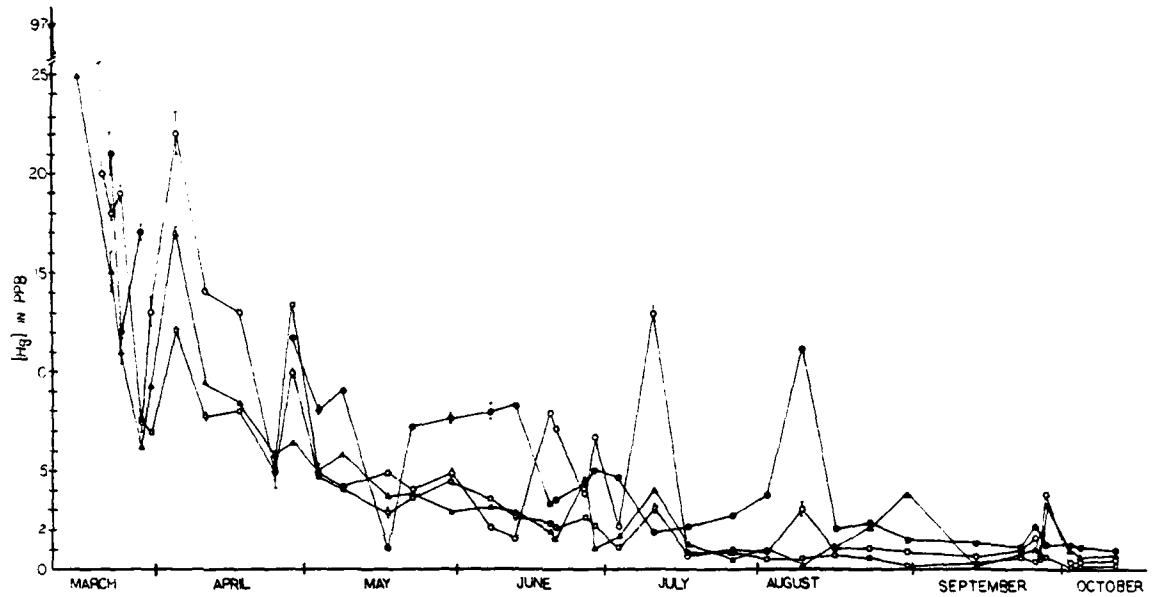
Fig. 7 - Mercury analyses at routine sampling points, quarters A (0), quarters I (●), quarters W-3 (Δ), and bldg. 6 coffee mess (□).

Continued Monitoring. Results of analyses of the four monitoring points to mid-October, 1978 are shown in Figure 7. There is an approximately exponential overall decay of mercury in the system as reflected at these sampling points. The initial wide variations are likely due to the frequent flushing of the distribution system. Most other variations can be explained by analysis of the sampling conditions and provide important information regarding the uncontrolled variables in the sampling of such a system. The system as a whole remained well below the 2 µg/l EPA limit after October 1, 1978. Periodic monitoring was maintained for several months to insure the integrity of the water system as the restored well was brought back on line and to satisfy Federal analysis requirements for post-contamination situations.

was iron, it became apparent that some of the variations seen in Figure 7 were due to leaching of mercury from the scale into water standing in these pipes. The data beginning in mid-July reflect an attempt to control this variable by running the tap long enough before sampling to flush the local plumbing. A calculation indicated that two minutes should be adequate in all cases at full flow to flush the standing water and provide a representative sample from the main. Except for the results of Qtrs. I, which was undergoing plumbing repair during this period which presumably dislodged scale, this sample control seemed to provide results indicative of mercury concentrations in the system as a whole. It did mean, however, that considerable time would be required to remove by flushing the remainder of the mercury entrained in scale in the local plumbing.

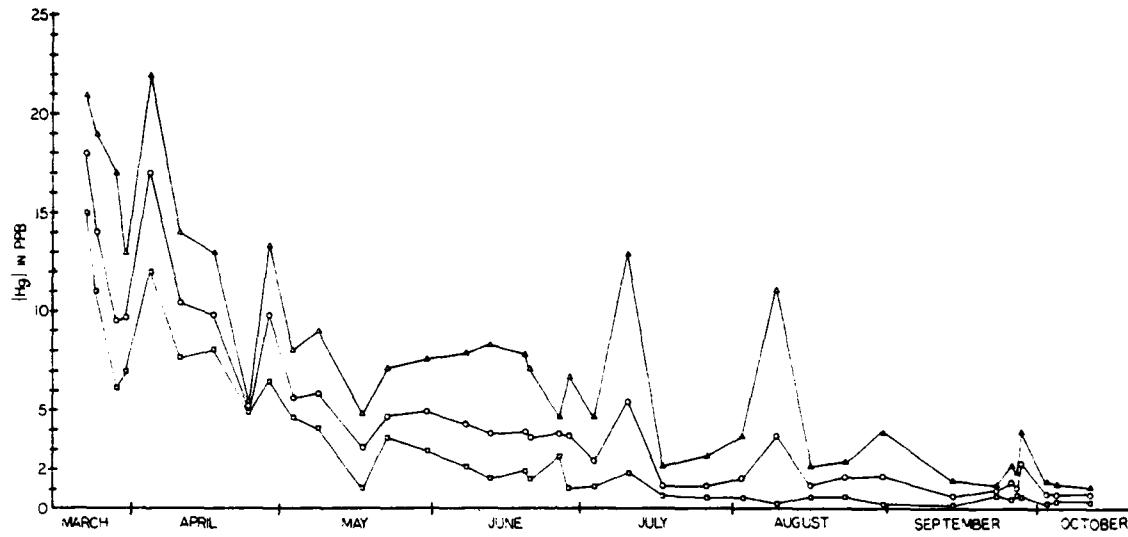
**Fig. 8 - Mercury analyses at routine sampling points,
highest value (Δ), mean (○), and lowest value (□).**

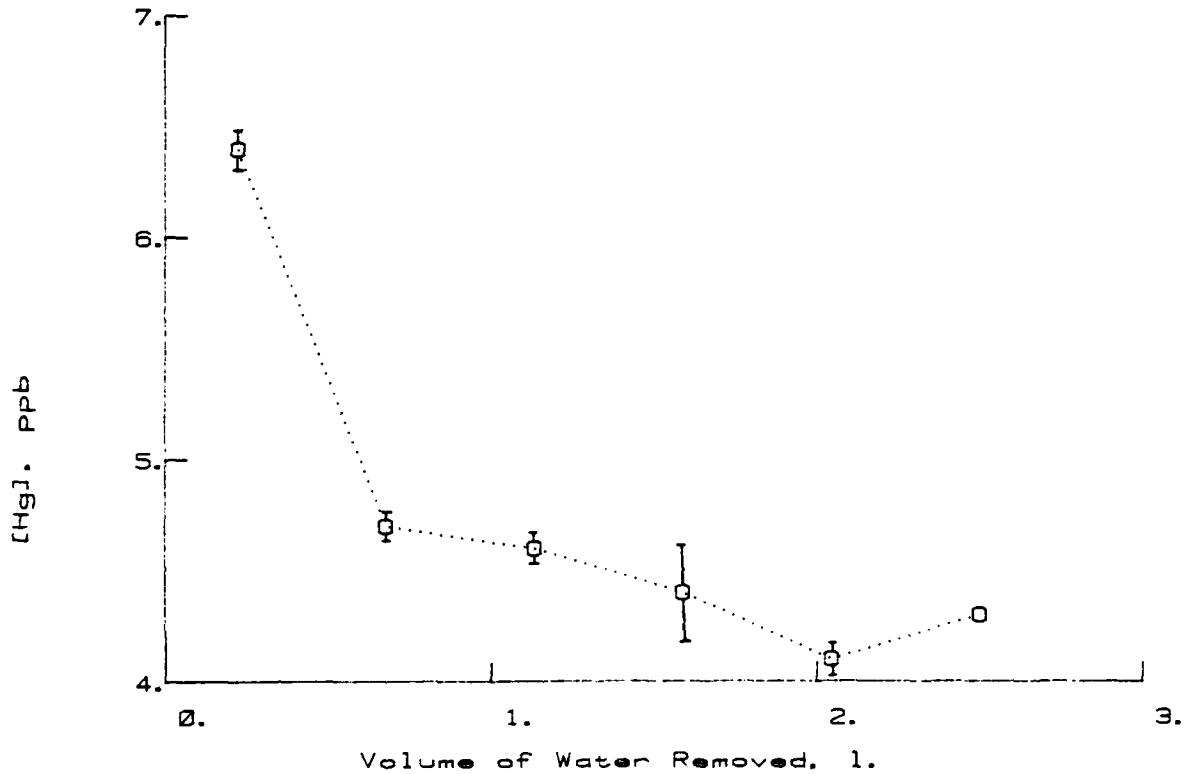
Fig. 9 - Mercury analyses of sequential samples collected at bldg. 6 site.
(Error bars are $\pm \sigma$.)
